The Tale of Udevara Palace
A Legacy of Royalty and Resilience

UDEVARA DODDAMANE DOCUMENTATION

ARCHITECTURAL
CONSERVATION
VIII SEM
BATCH - 2021

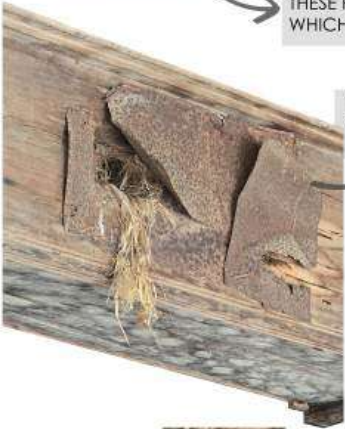
THE LINTELS ARE DAMAGED BY THE PESTS AND OTHER TIMBER INWADERS , MAKING IT A HUGE SURFACE AND BIRD'S NEST IN THE END

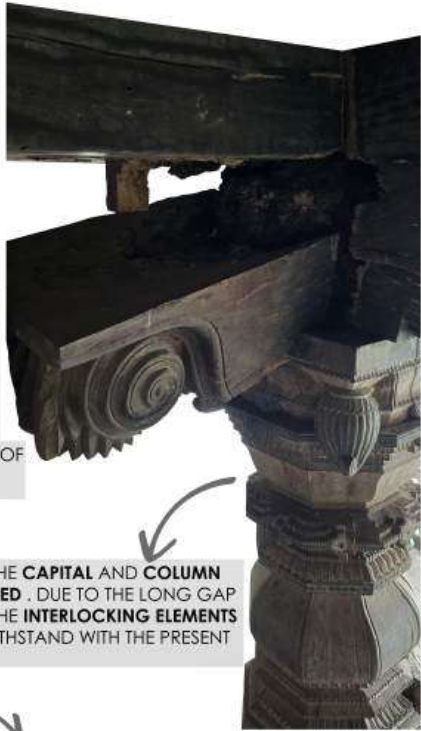
THE TIMBER USED IN THE LINTELS HAVE DISLOCATED AND OVER THE TIME THE WOOD HAS ABSORBED THE WATER CONTENT LEADING TO LOSING OF THE APPEARANCE .

THE JOINERIES OF THE CAPITAL AND COLUMN ARE BEING DETACHED . DUE TO THE LONG GAP THE ADHESIVE OR THE INTERLOCKING ELEMENTS HAVE FAILED TO WITHSTAND WITH THE PRESENT CONDITIONS .

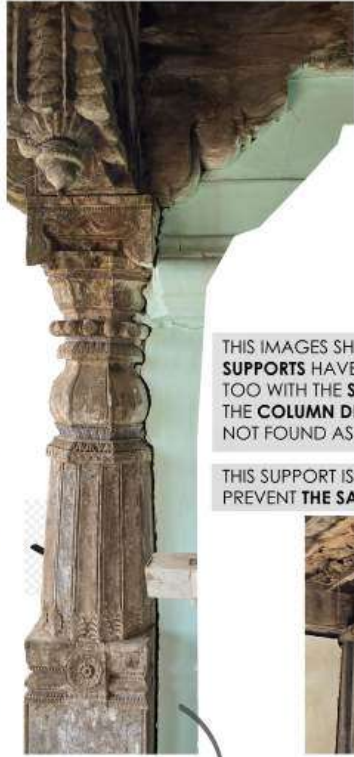
THIS IMAGES SHOWS US HOW THE EXTERNAL SUPPORTS HAVE BEEN PROVIDED , THAT TOO WITH THE SIMILAR INSTALLATION OF THE COLUMN DESIGN TO MAKE SURE IT IS NOT FOUND AS A LATER ADDITION .

THIS SUPPORT IS PROVIDED IN ORDER TO PREVENT THE SAG OF THE TIMBER BEAM .

THIS IMAGES SHOWS US HOW THE COLUMN MADE OF TIMBER AND THE WALL MADE UP OF MUD - HAS BEEN DETACHED OVER THE TIME. THIS IS BECAUSE OF WEATHERING AND NO MAINTAINANCE CARRIED OUT .

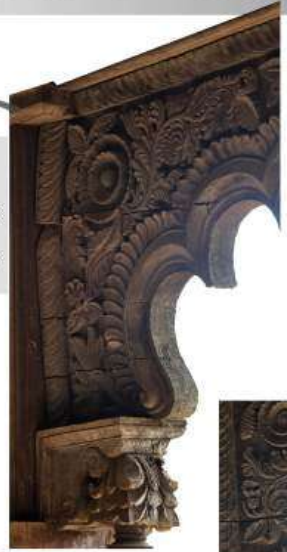
THIS PICTURE AGAIN TELLS US THE DETERIORATION OF THE COLUMNS . EXTENSIVE PEST ATTACK HAS MADE THE CORE OF THE COLUMN VERY WEAK AND IS AT THE EDGE OF COLLAPSING .

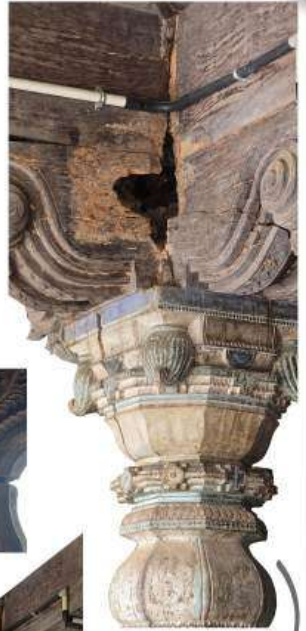
DUE TO THE EXPOSURE TO MOIST CONDITIONS THIS PICTURE TELLS US HOW THE DECAY OF THE TIMBER HAS TAKEN PLACE HIGHLIGHTING THE ROTTEN PART .

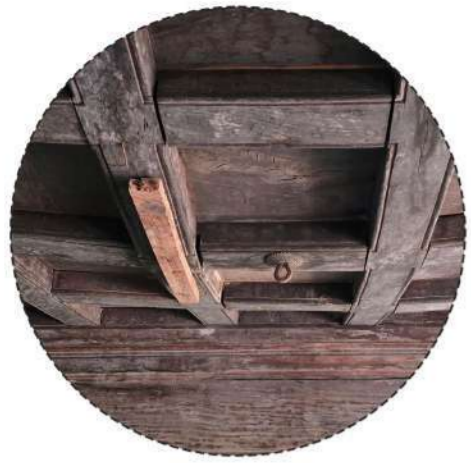
DEFLECTION, INDICATES STRUCTURAL STRESS.

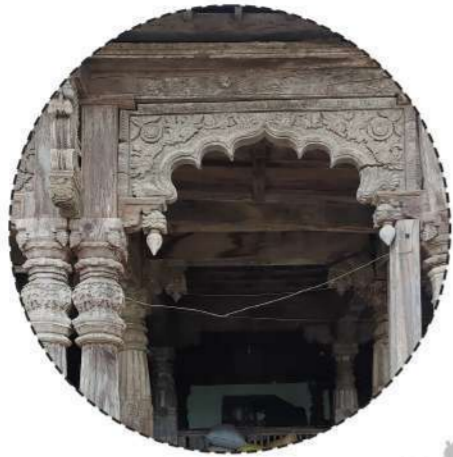
SURFACE DARKENING AND MORTAR LOSS DUE TO WEATHERING.

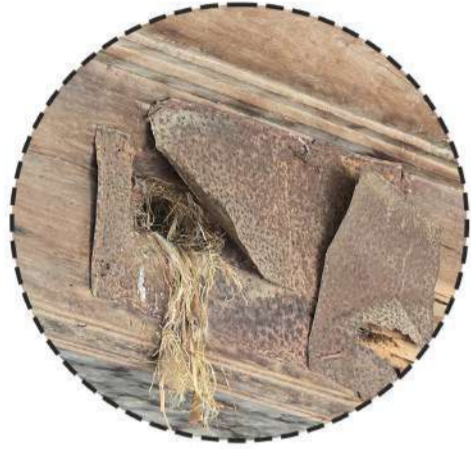
FRAYING AND DAMAGE SUGGEST INSECT ATTACK AND AGING.

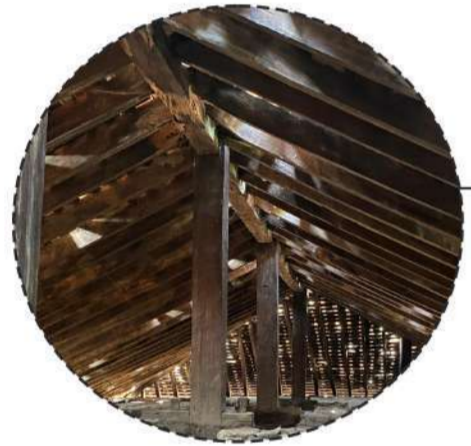
UNEVEN RAFTERS; SIGNS OF SAGGING OR DEFORMATION.

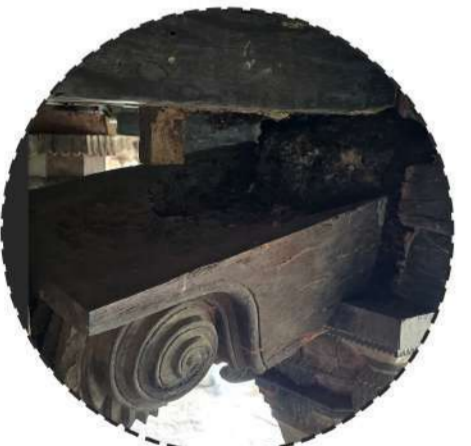
INDICATES STRUCTURAL MOVEMENT OR SETTLING.

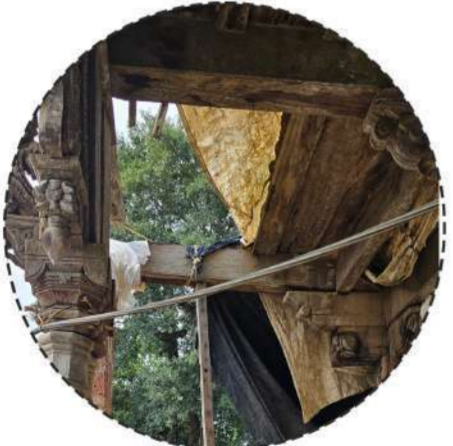
DAMAGED ROOF STRUCTURE

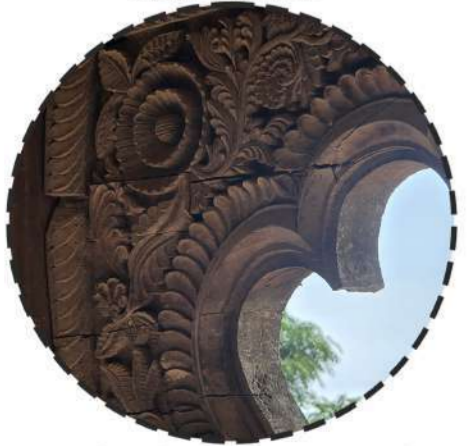
CRACKS ON ELEMENTS

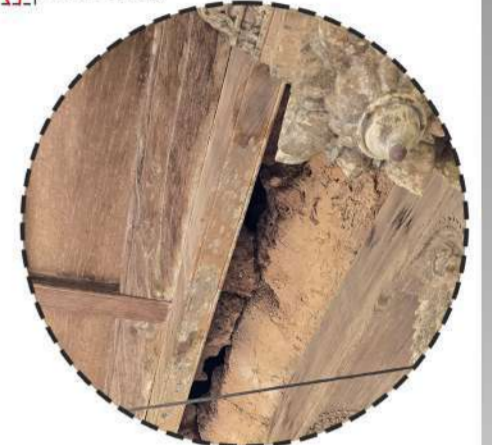
SHOWS DECAY, SPLITTING, AND SIGNS OF INSECT INFESTATION

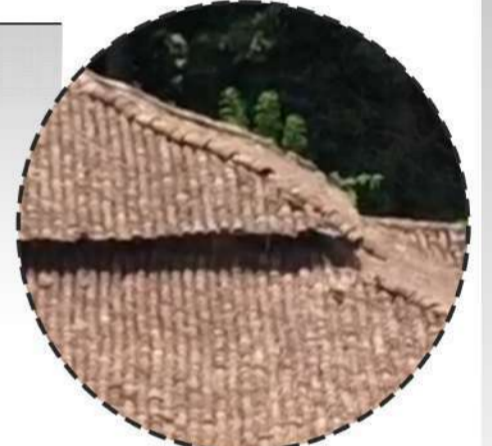
DISPLACED AND BROKEN TILES INDICATE STRUCTURAL MOVEMENT OR WEATHER DAMAGE.

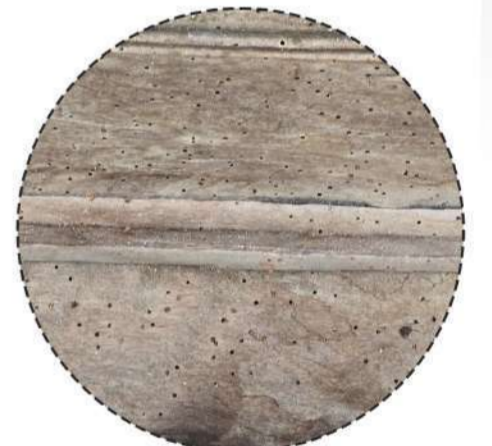
EVIDENT EROSION AND PITTING SUGGEST WEATHERING AND SALT ACTION.

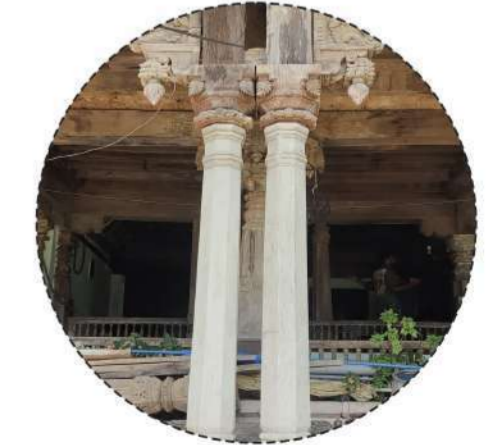
MINOR STAINING AND DAMPNESS AT THE BASE.

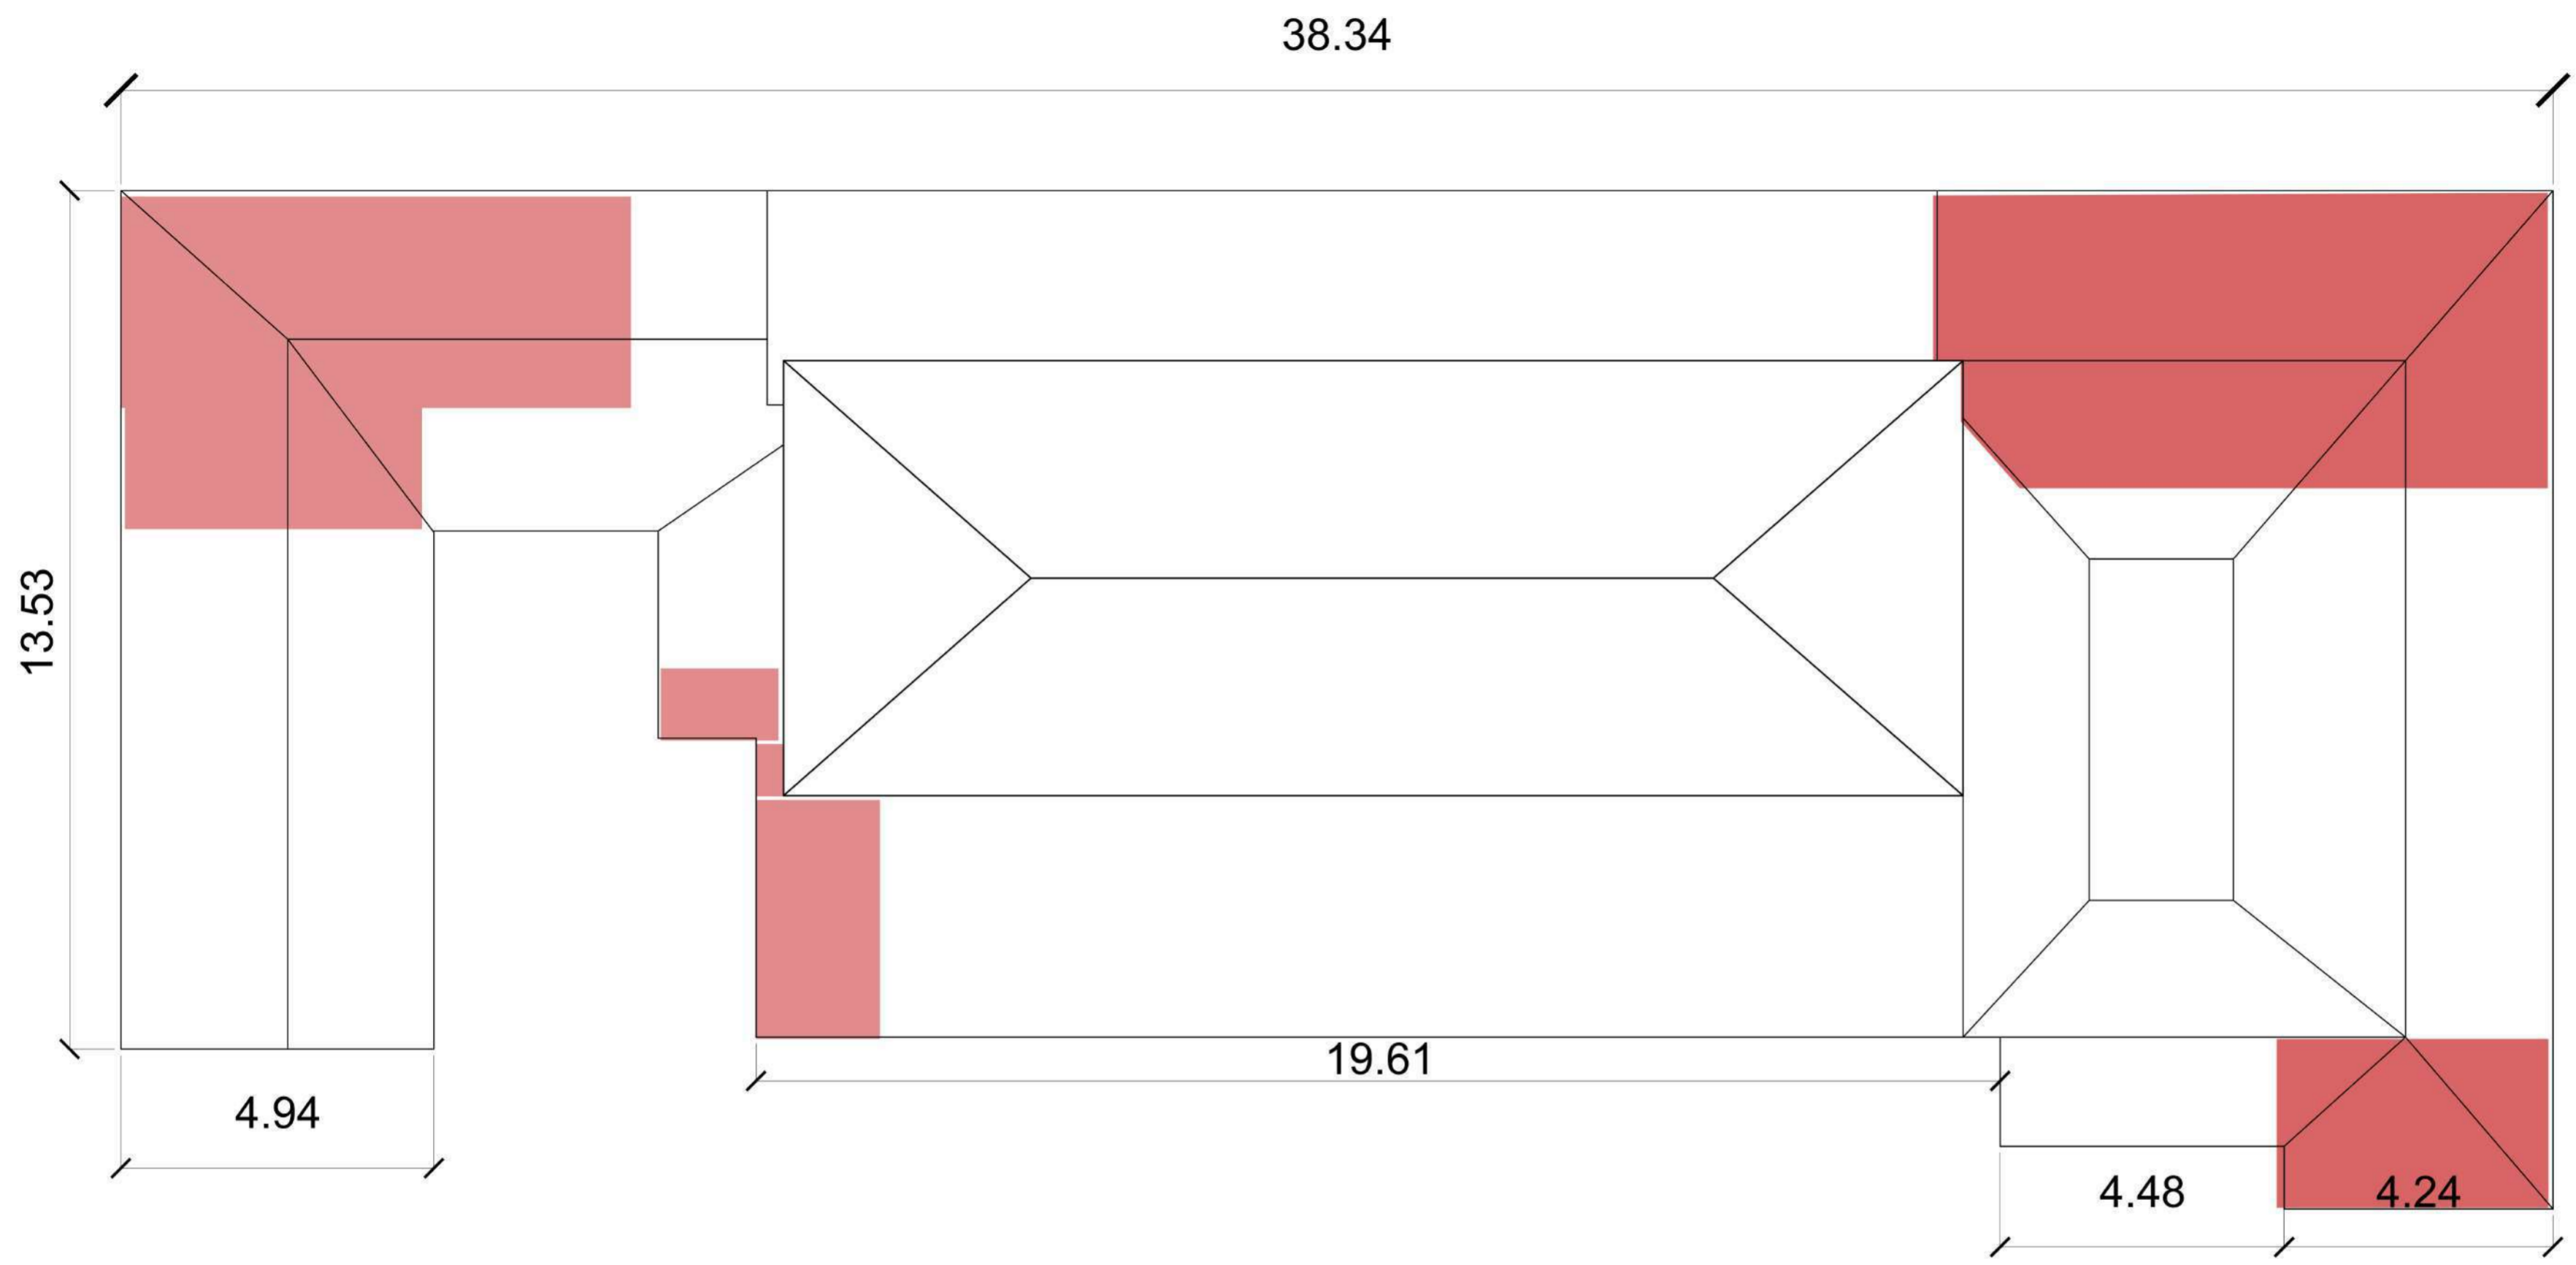
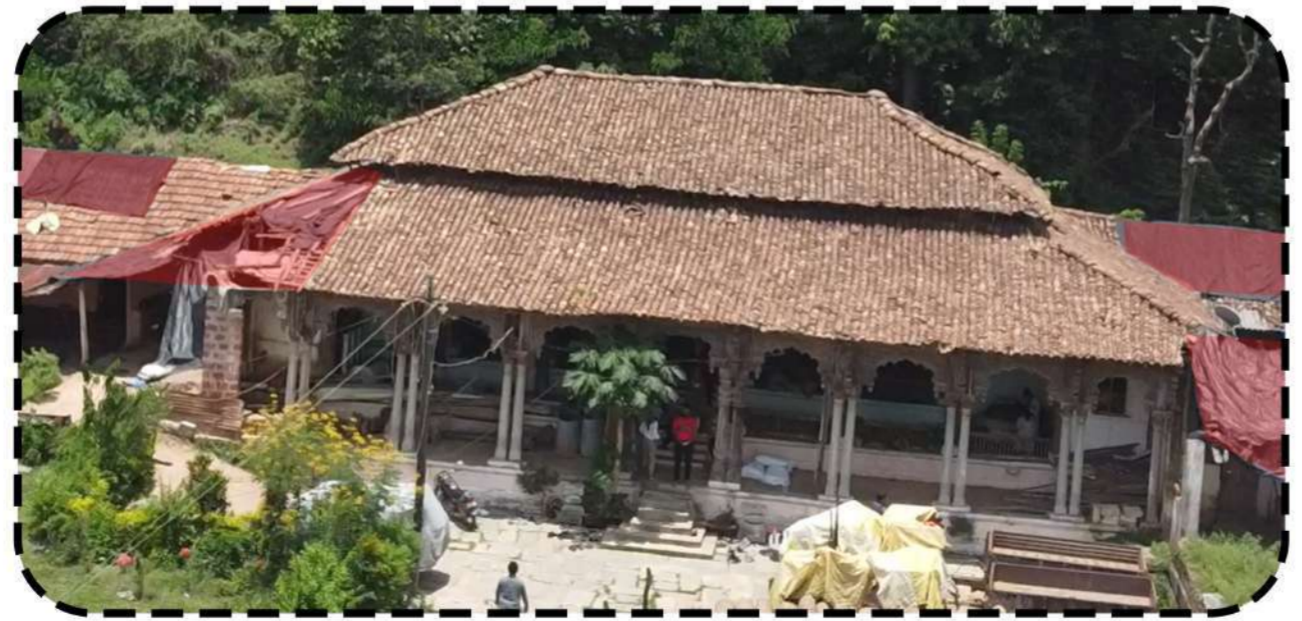
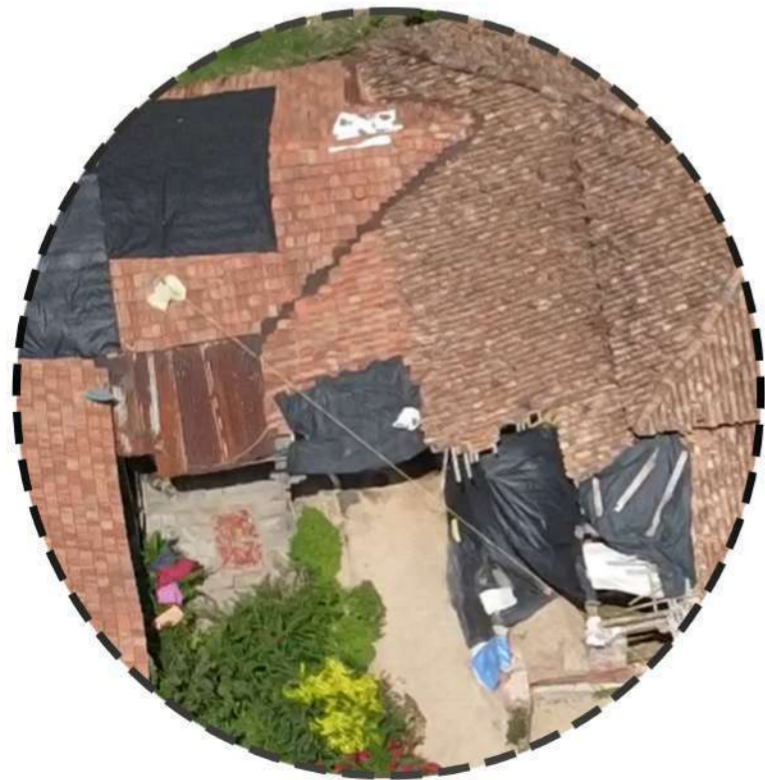
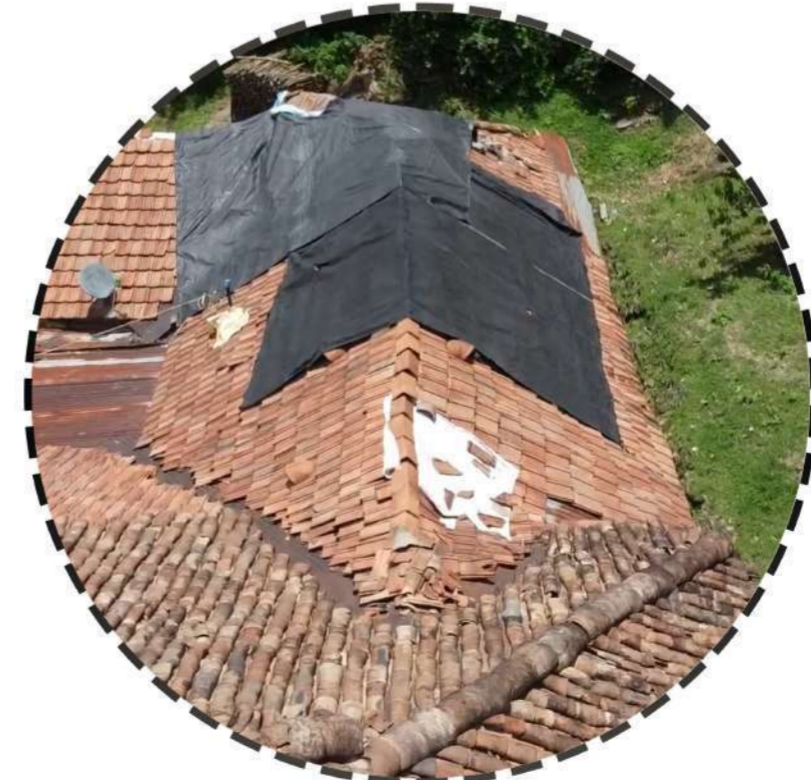
CONDITION ASSESMENT

SOME PARTS OF THE ROOF IS DAMAGED AND COVERD WITH TARPAULIN ,THE REASON IS IT IS NOT WELL MAINTAINED IS AFFECTED DUE TO HARSH WEATHER CONDITION . THE TYPE OF ROOF TILE IS USED IS BARREL C LAY TILE.
