The Tale of Udevara Palace
A Legacy of Royalty and Resilience

UDEVARA DODDAMANE DOCUMENTATION

ARCHITECTURAL
CONSERVATION
VIII SEM
BATCH - 2021

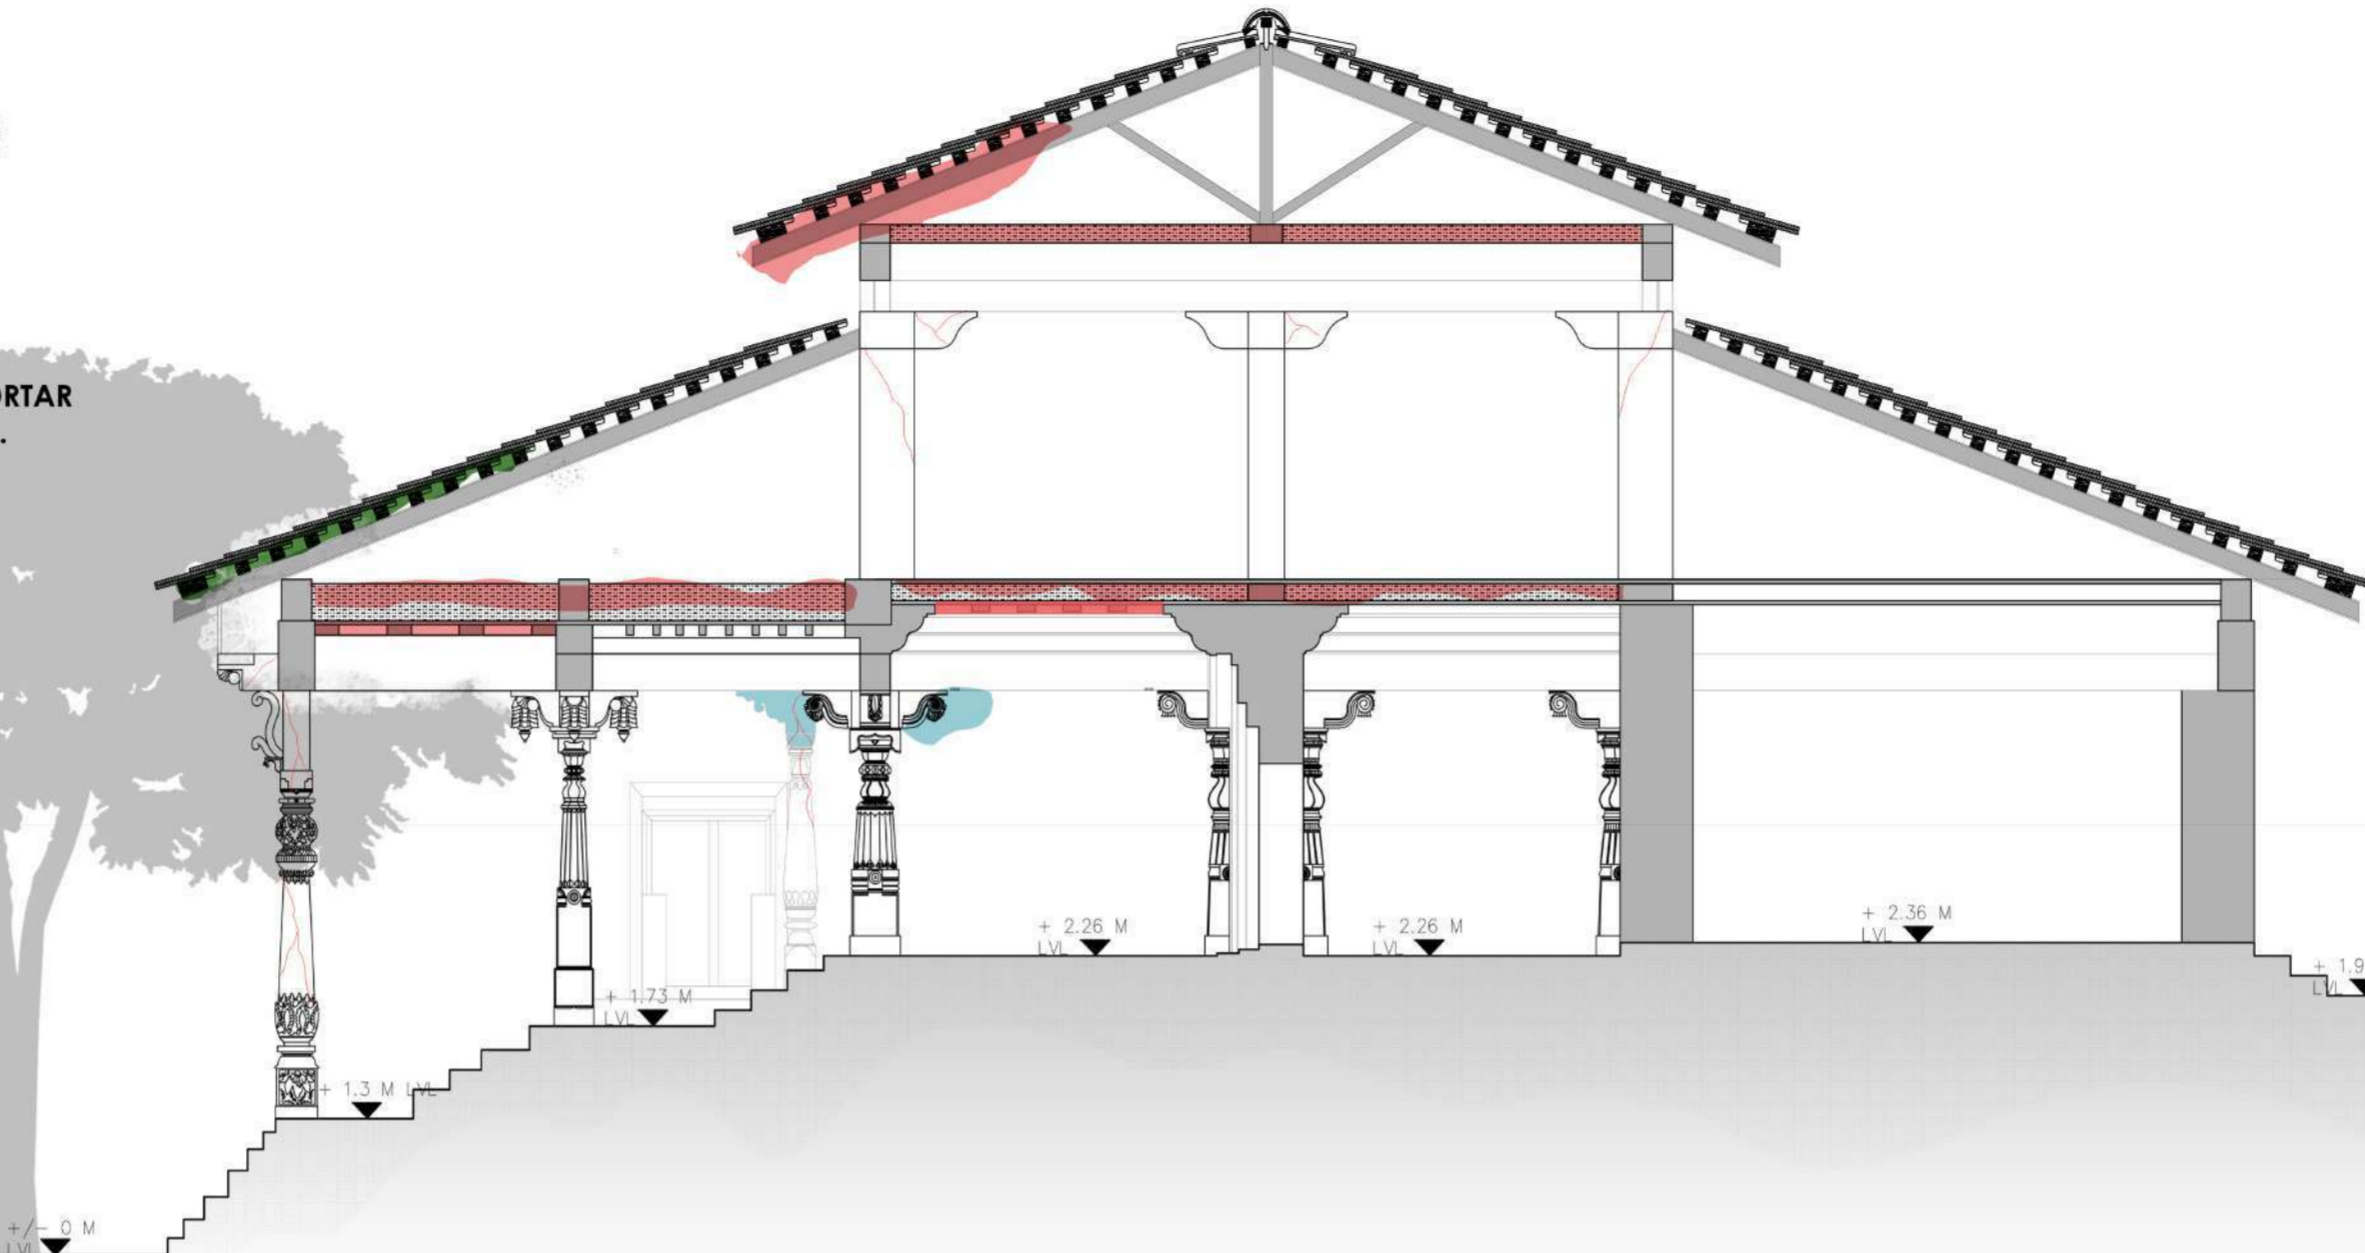
- DEFLECTION
- DETERIORATION
- TERMITE ATTACK
- RENOVATED
- EXPOSURE TO MOSITURE
- CRACKS

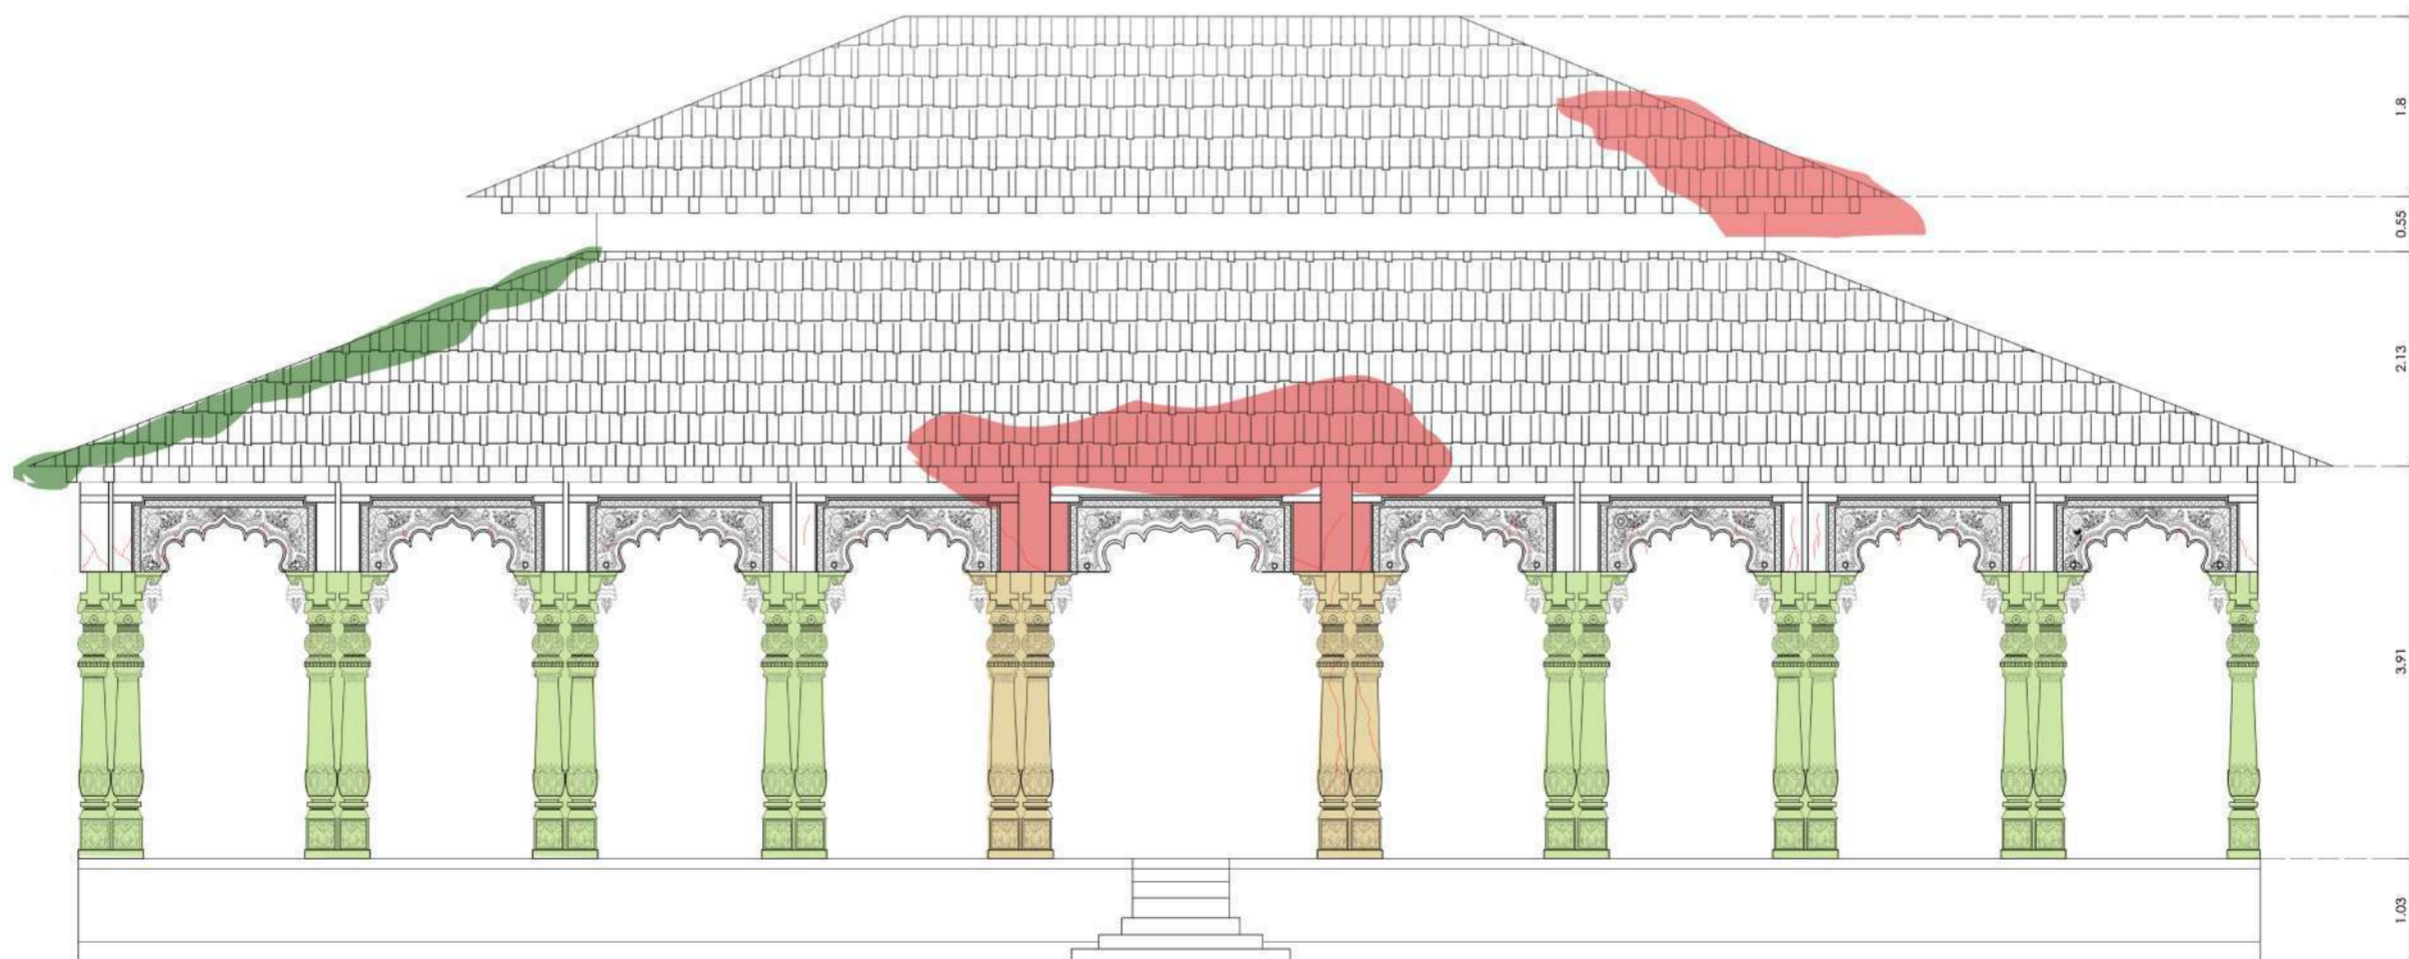
SOME PARTS OF THE ROOF IS DAMAGED AND COVERD WITH TARPAULIN ,THE REASON IS IT IS NOT WELL MAINTAINED IS AFFECTED DUE TO HARSH WEATHER CONDITION . THE TYPE OF ROOF TILE IS USED IS BARREL C LAY TILE.
